CARR-1186

**National Register of Historic Places
Inventory—Nomination Form**See instructions in *How to Complete National Register Forms*
Type all entries—complete applicable sections**1. Name**

historic Frizzell, Andrew P., House and Farm Complex

7. Description

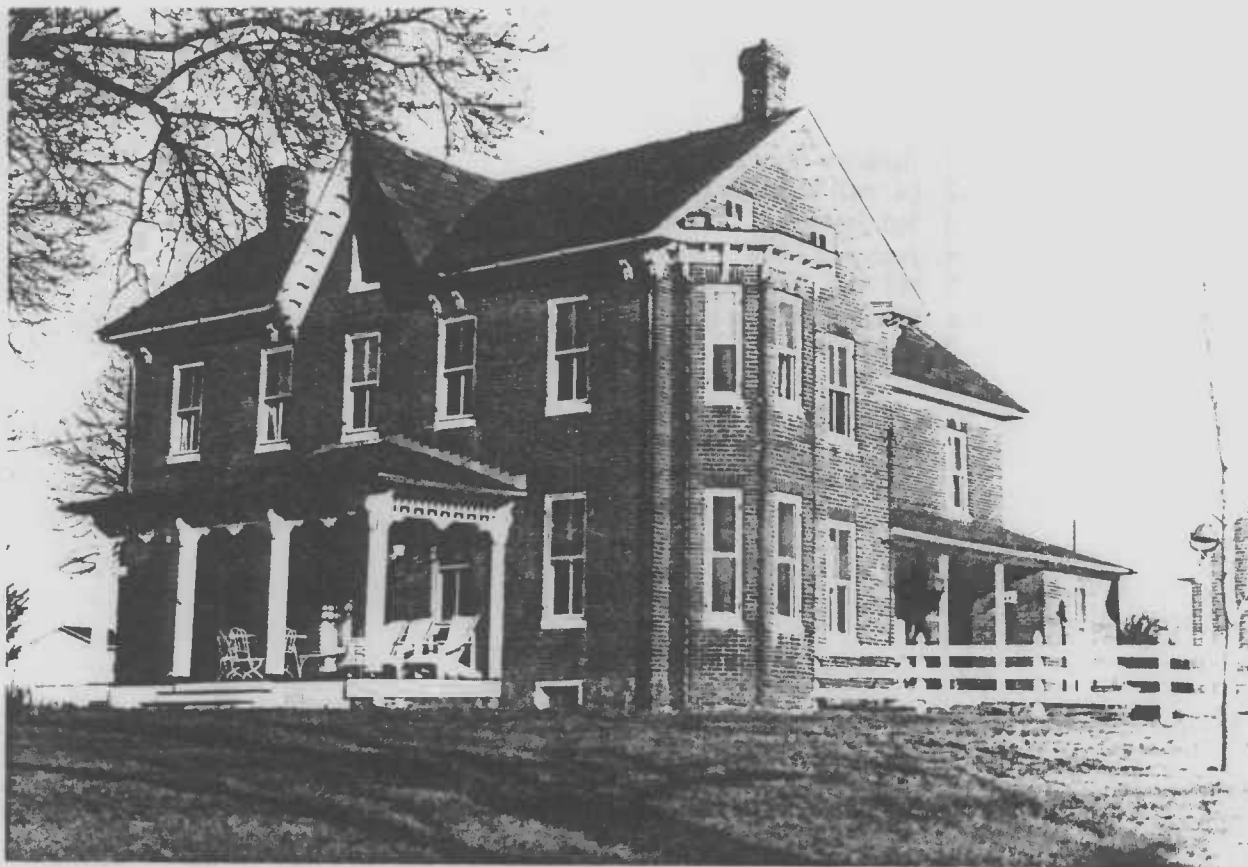
1. Andrew P. Frizzell House
2. Carroll County, Maryland
3. Joe Getty
4. January 1986
5. Md. Hist. Trust, Annapolis, Md.
6. South & west elevations (camera facing ne)
7. 30/31

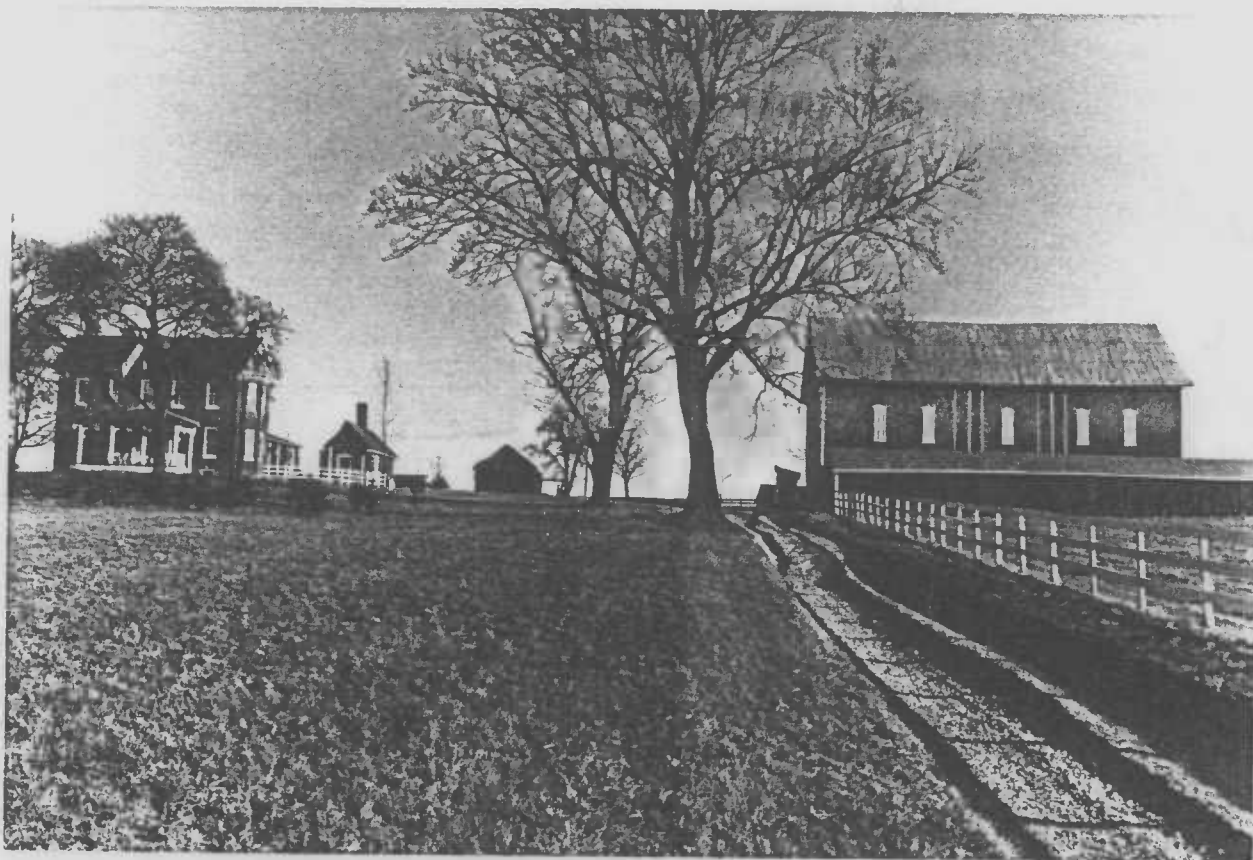
1. Andrew P. Frizzell House
2. Carroll County, Maryland
3. Joe Getty
4. January 1986
5. Md. Hist. Trust, Annapolis, Md.
6. Overview of site (camera facing e)
7. 31/31

The outbuildings in the farm complex have remained relatively intact. An early photograph (from 1896-1905) shows a view of the farm from the west (camera facing east), and the layout of the Victorian farmstead has basically been preserved. The photograph shows that a large windmill pump stood on the south side of the house in front of the washhouse, and the foundation for the windmill (that served the wooden cistern in the attic) is still intact.

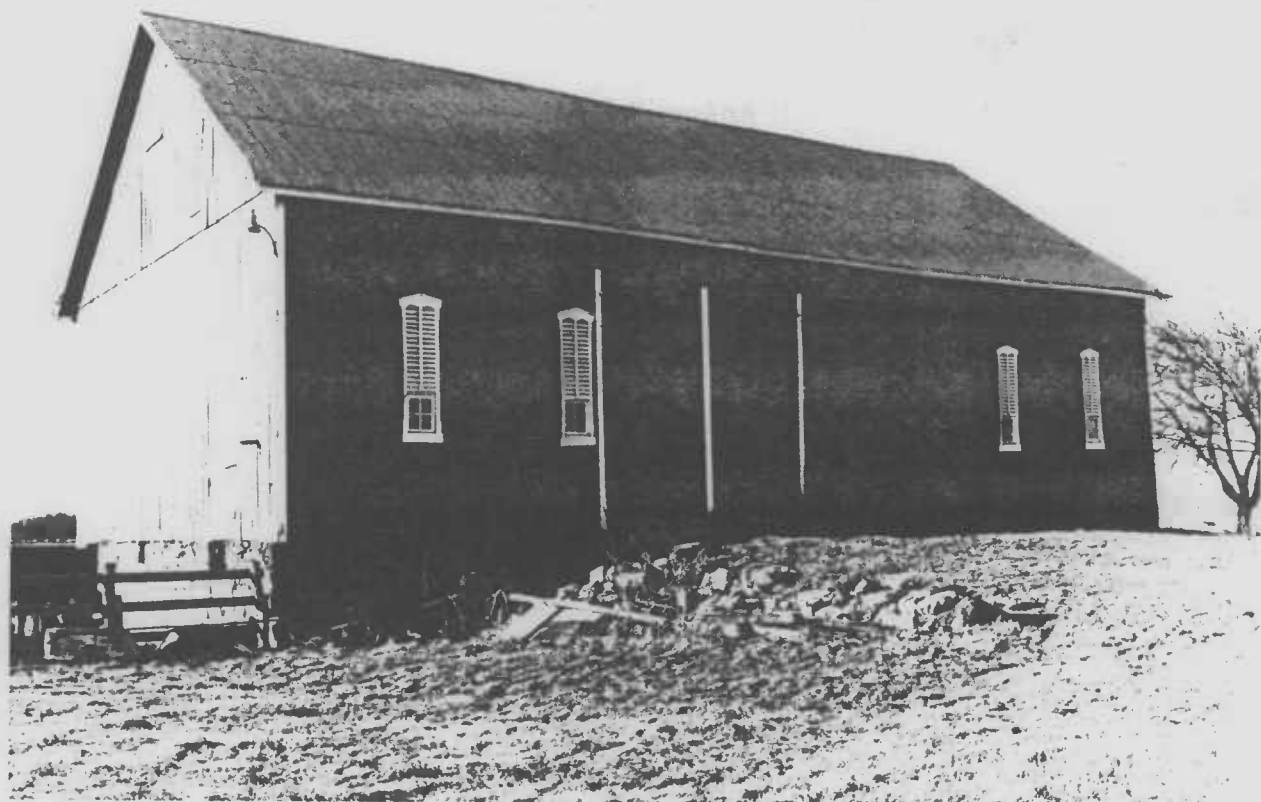
1. Andrew P. Frizzell House
2. Carroll County, Maryland
3. Joe Getty
4. January 1986
5. Md. Hist. Trust, Annapolis, Md.
6. Bank barn--s & n elev.
7. 28/29

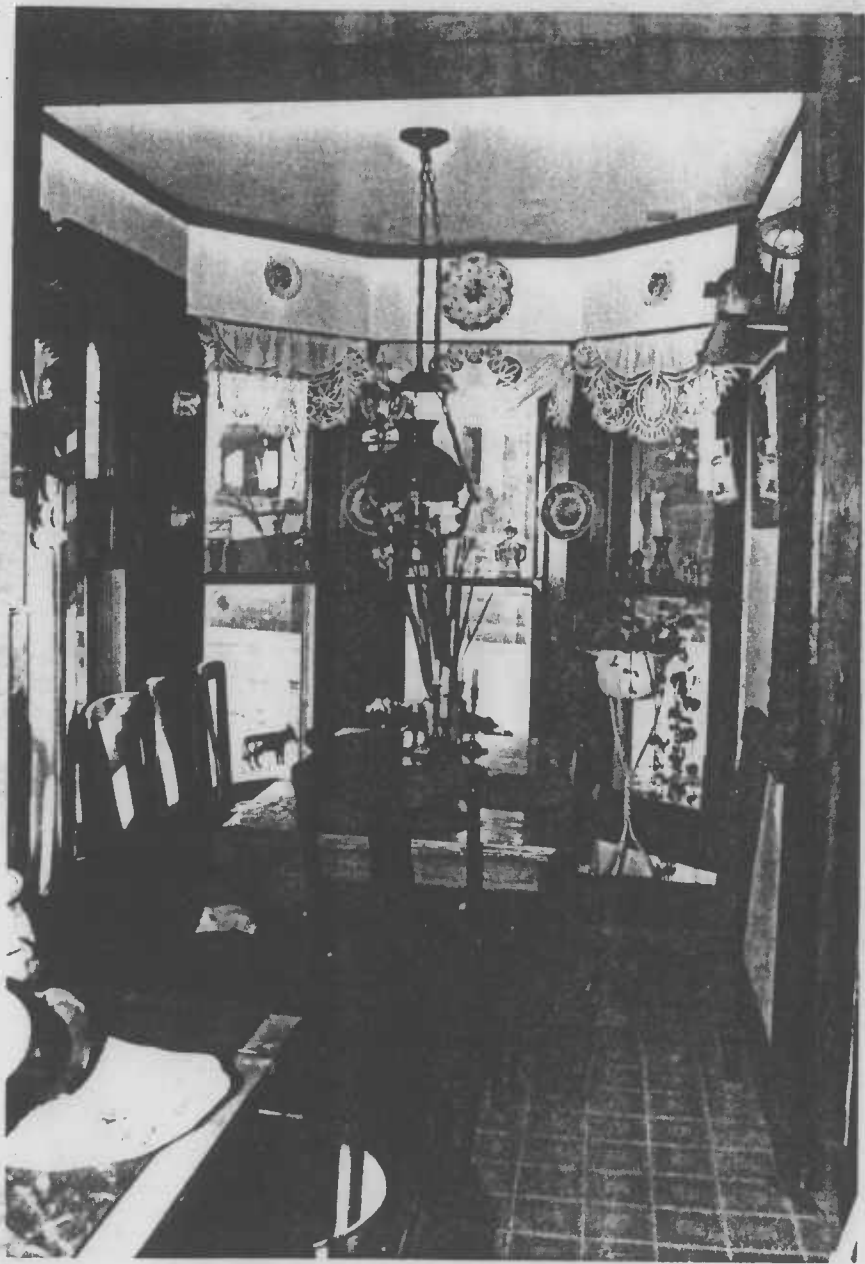
1. Andrew P. Frizzell House
2. Carroll County, Maryland
3. Joe Getty
4. January 1986
5. Md. Hist. Trust, Annapolis, Md.
6. Kitchen--s bay window
7. 15/29

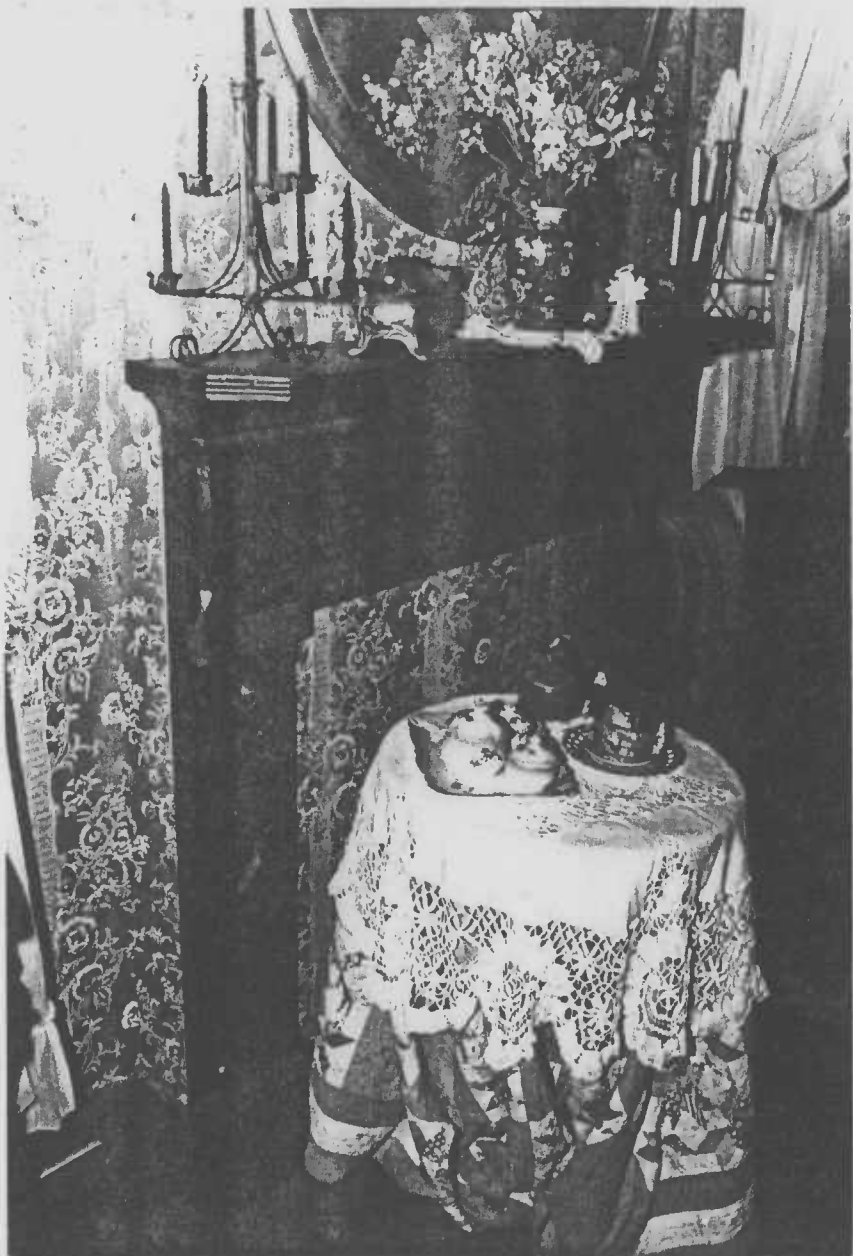
-
1. 1986
1. Andrew P. Frizzell House
 2. Carroll County, Maryland
 3. Joe Getty
 4. January 1986
 5. Md. Hist. Trust, Annapolis, Md.
 6. nw bedroom--Mantelpiece
 7. 16/29

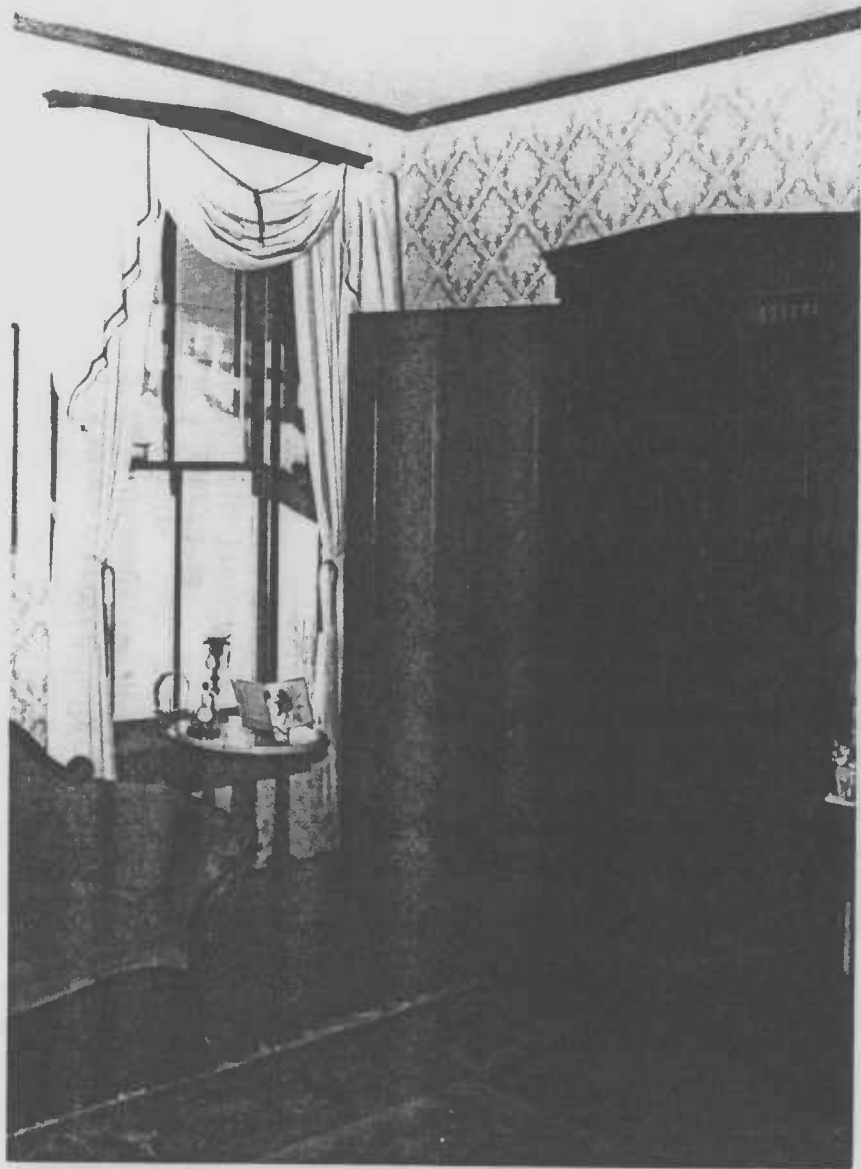
1. Andrew P. Frizzell House
2. Carroll County, Maryland
3. Joe Getty
4. January 1986
5. Md. Hist. Trust, Annapolis, Md.
6. Parlor--Mantelpiece
7. 9/29

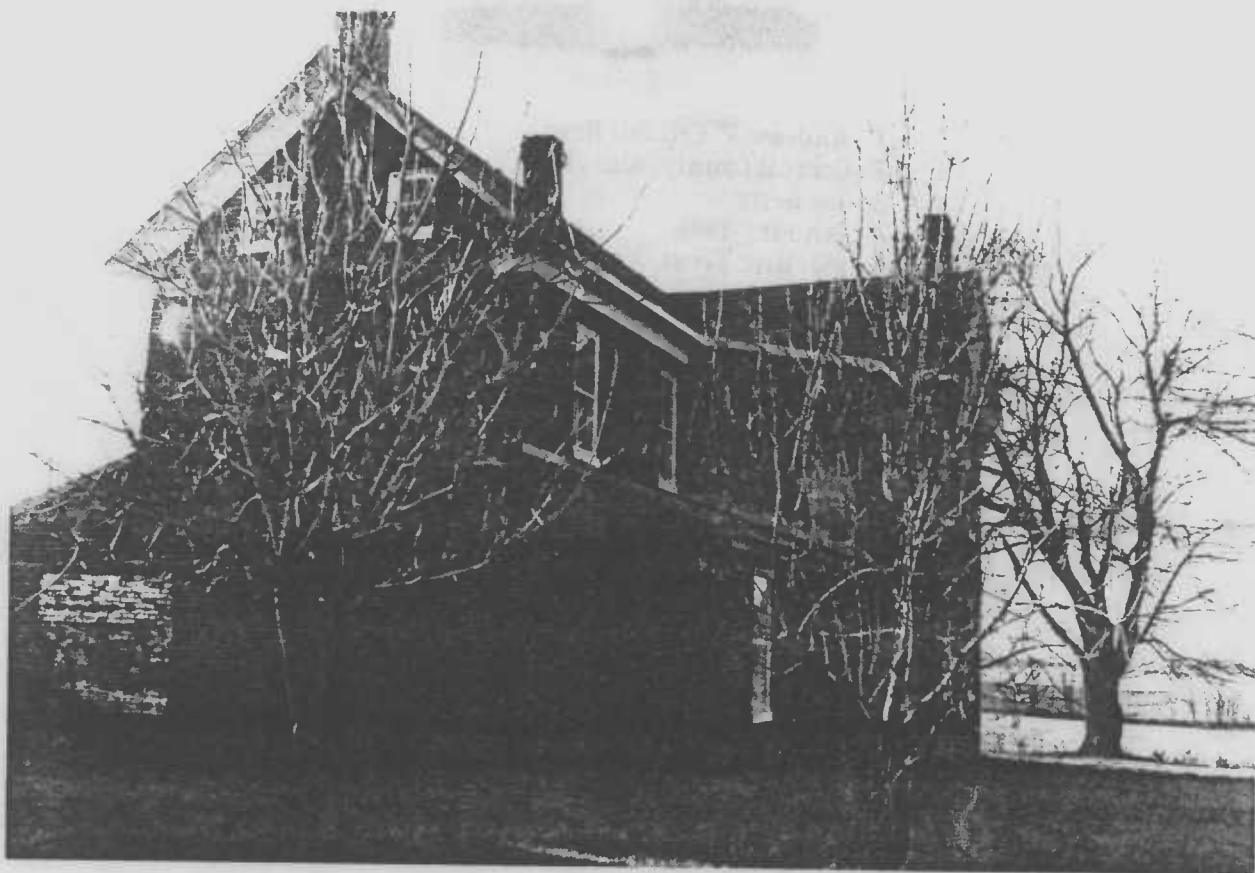
1. Andrew P. Frizzell House
2. Carroll County, Maryland
3. Joe Getty
4. January 1986
5. Md. Hist. Trust, Annapolis, Md.
6. n & e elevation (cam. fac. sw)
7. 5/29

The wing is a centrally-located, three-bay long section on the east facade of the main block and thus forms the T-shaped plan. There are no existing window openings on the east side of the main block of the house. In the northwest corner of the wing, a two-story modern brick addition was added in 1977 to replace a frame bathroom on the second story (that was supported by the porch roof). The second story frame bathroom dated from the 1920s and was in a deteriorated condition. The brick replacement contains a bathroom on the second story and a laundry room on the first story. This addition is unobtrusively designed and has a shed roof and two-over-two sash windows on its north facade. A one-story porch with a shed roof exists on the south facade of the wing and on the north facade in the area remaining from the addition. The easternmost bay of the porch on both sides is enclosed by an original brick projection with a two-over-two sash window. In the southwest corner of the wing is a frame projection with a three-sided bay window under the one-story porch. Originally, the second story of both sides contained two-over-two sash windows with flat jack-arches in each of the three bays. The east gable end of the wing is unfenestrated except for two square windows in the gable.

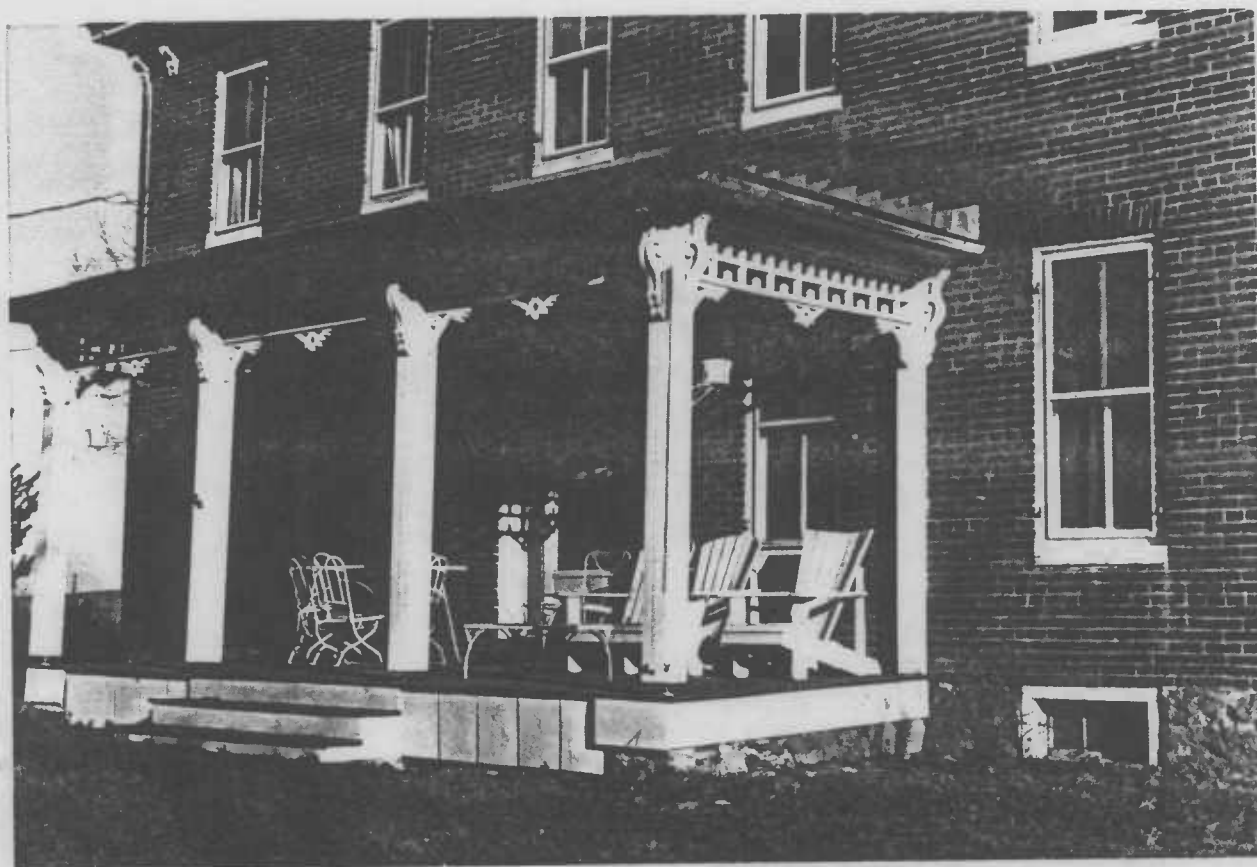
hipped roof. The porch is supported by square posts that have elaborate serpentine brackets. Running between the posts is an ornamental stick pattern with brackets and drops containing floral motifs. The main cornice of the house contain a pattern of scroll brackets interspersed with a row of plain serpentine brackets.

1. Andrew P. Frizzell House
2. Carroll County, Maryland
3. Joe Getty
4. January 1986
5. Md. Hist. Trust, Annapolis, Md.
6. w elevation-porch detail
7. 4/29

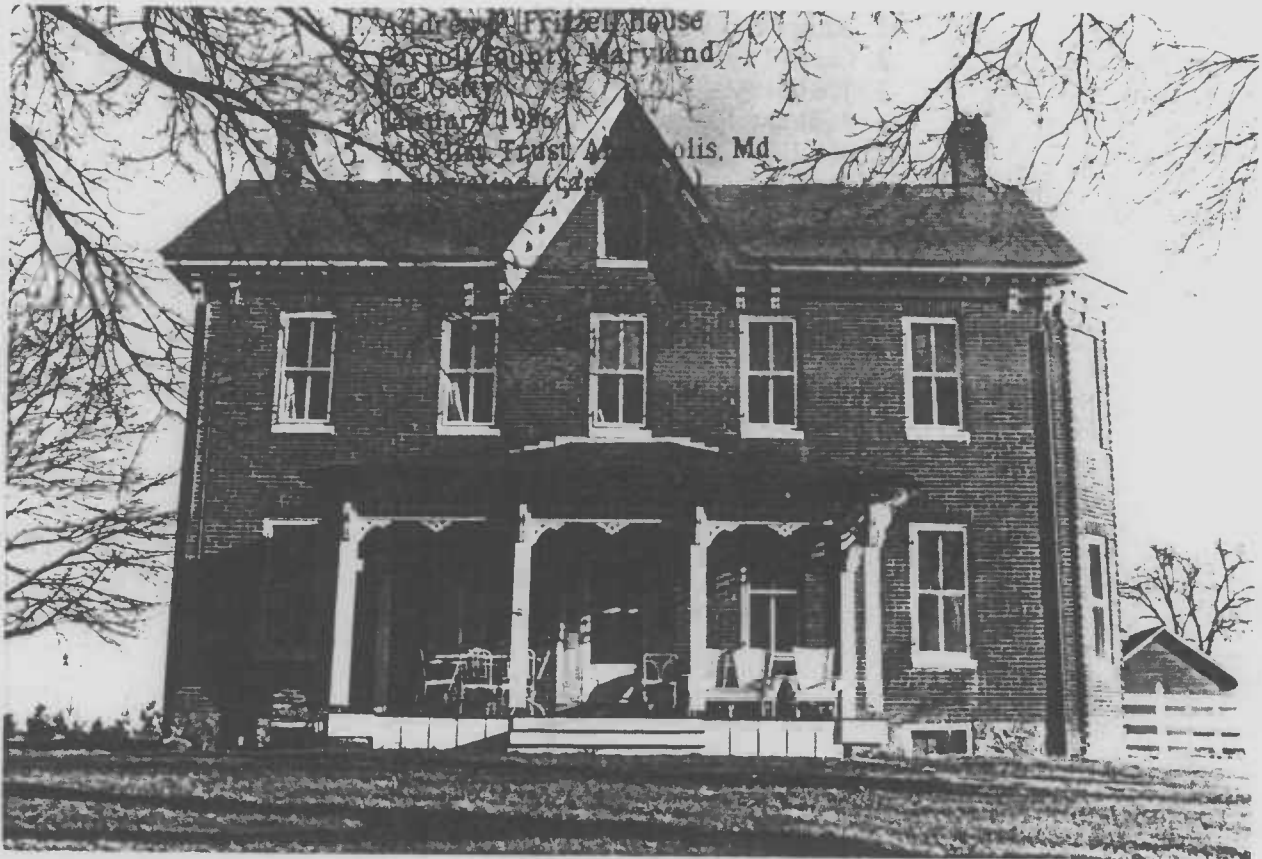
The main facade (facing west) is five bays wide with a central entrance on the first story and two-over-two sash windows on the other bays of the first and second stories. The windows have flat jack-arches and wooden sills. The central entrance has a granite sill, a three-pane transom, three-pane sidelights with paneling, and a four paneled door. This facade is highlighted by Victorian style trim including a gabled dormer with round-arched window, a bracket cornice, and a one-story, three-bay porch with

1. Andrew P. Frizzell House
2. Carroll County, Maryland
3. Joe Getty
4. January 1986
5. Md. Hist. Trust, Annapolis, Md.
6. w elevation (cam. fac. e)
7. 2/29

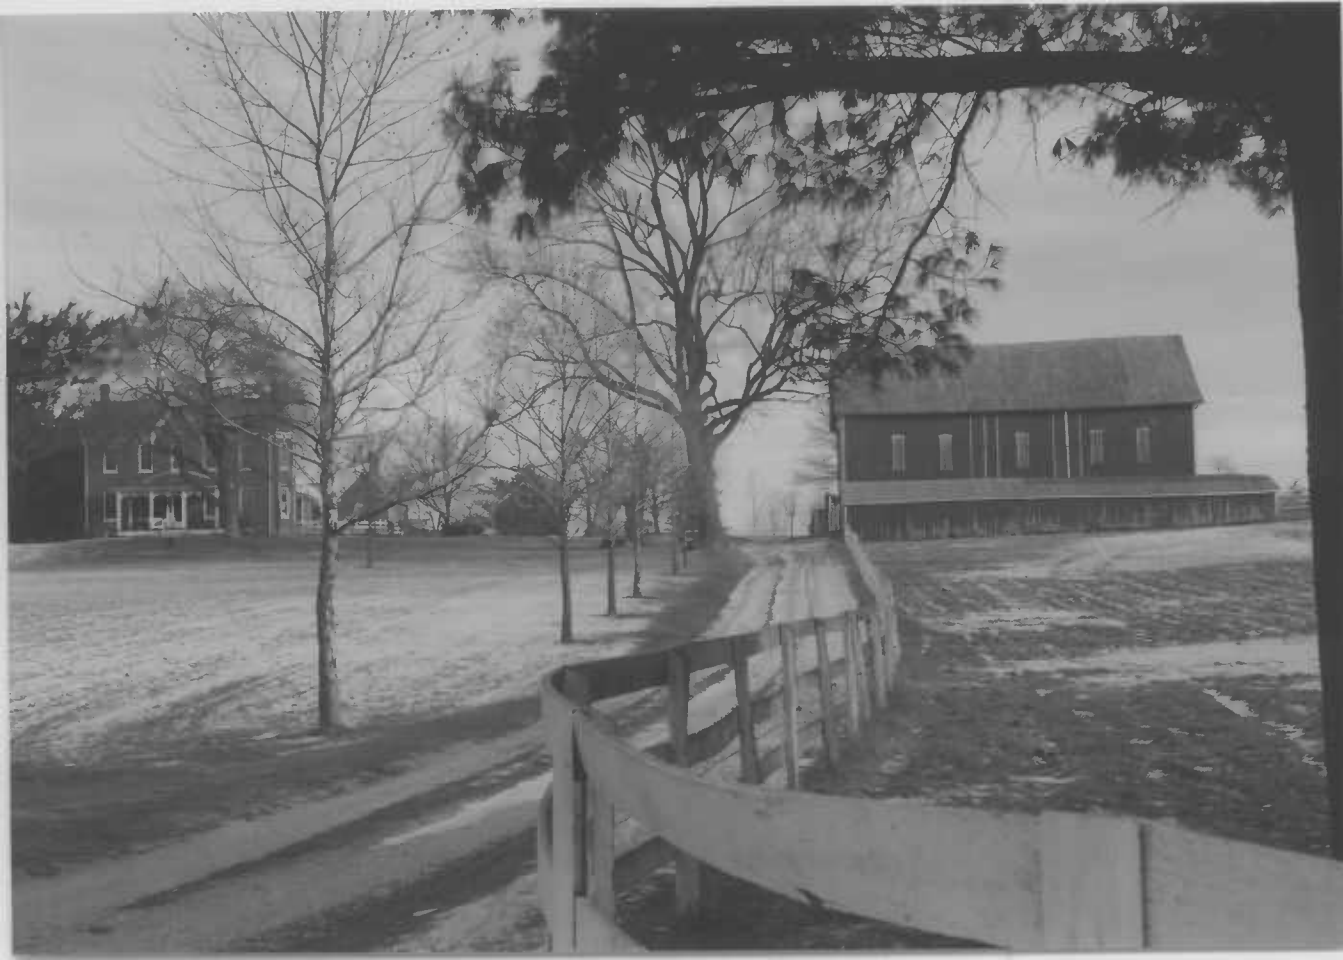
A.P. FRIZZELL HOUSE & FARM MILP# CARR-1186
3801 SALEM BOTTOM ROAD
WESTMINSTER, CARROLL COUNTY, MD 21157
PHOTO BY WILLIAM RIGGS 01.23.03
NEAR WIND SHED
HOUSE & BARN, FROM ROAD 1/2

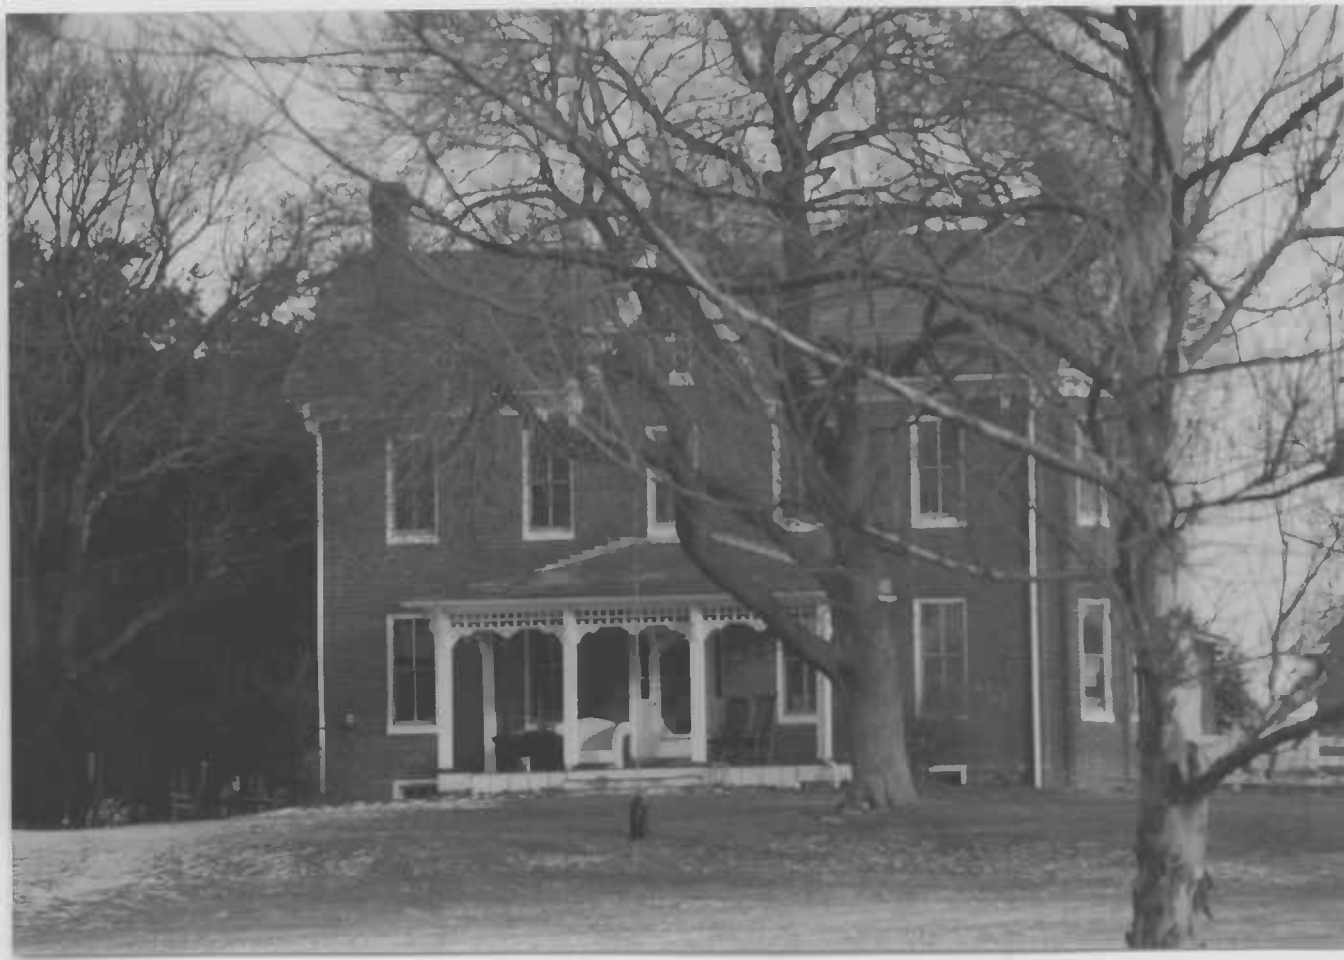
A.P. FRIZZELL HOUSE & FARM NINE # CARR-1186
3801 SALEM BOTTOM ROAD
WESTMINSTER, CARROLL CO., MD 21157
PHOTO BY WILLIAM RIGGS 01.28.03
NEG W/MD 34FO
HOUSE, FRONT ELEVATION 2/2
